From Allis Chalmers D14 Operator's manual. Procedure is correct for others, specified clearance may be different. Always check and use the specified clearances for the engine being adjusted.

VALVE TAPPET CLEARANCE

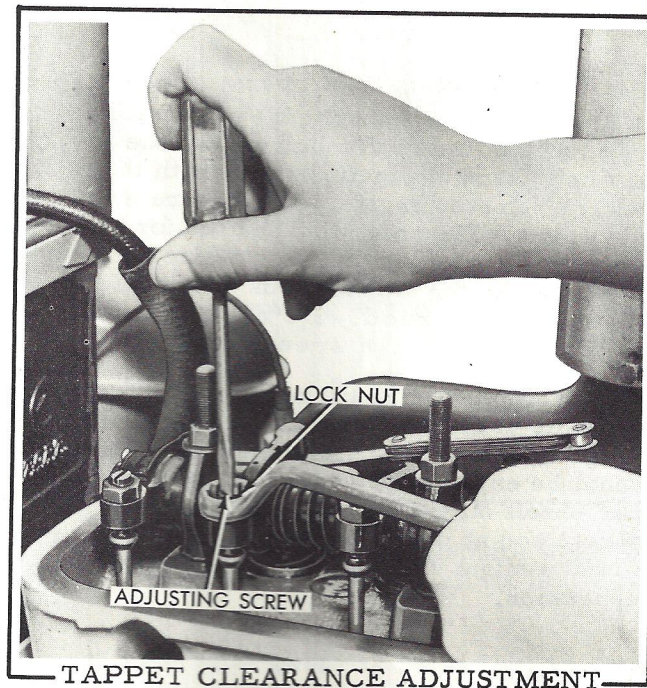
To adjust clearance, turn engine with crank until valve closes and push rod is at its lowest position.

Loosen valve adjusting screw lock nut and turn screw until there is .012" clearance between valve stem and rocker arm. Tighten lock nut and recheck.
